## 2015 DASH SUMMARY CROOKED AND BASS LAKES, OCONTO COUNTY, WI

*NOTE: This is a report only of the 2015 DASH efforts for Crooked Lake and serves as a companion report to the Crooked Lake Protection and Rehabilitation District Eurasian Water Milfoil Treatment Report prepared by Onterra in January, 2015. Please consult that report for further management details for the overall Crooked Lake project.*

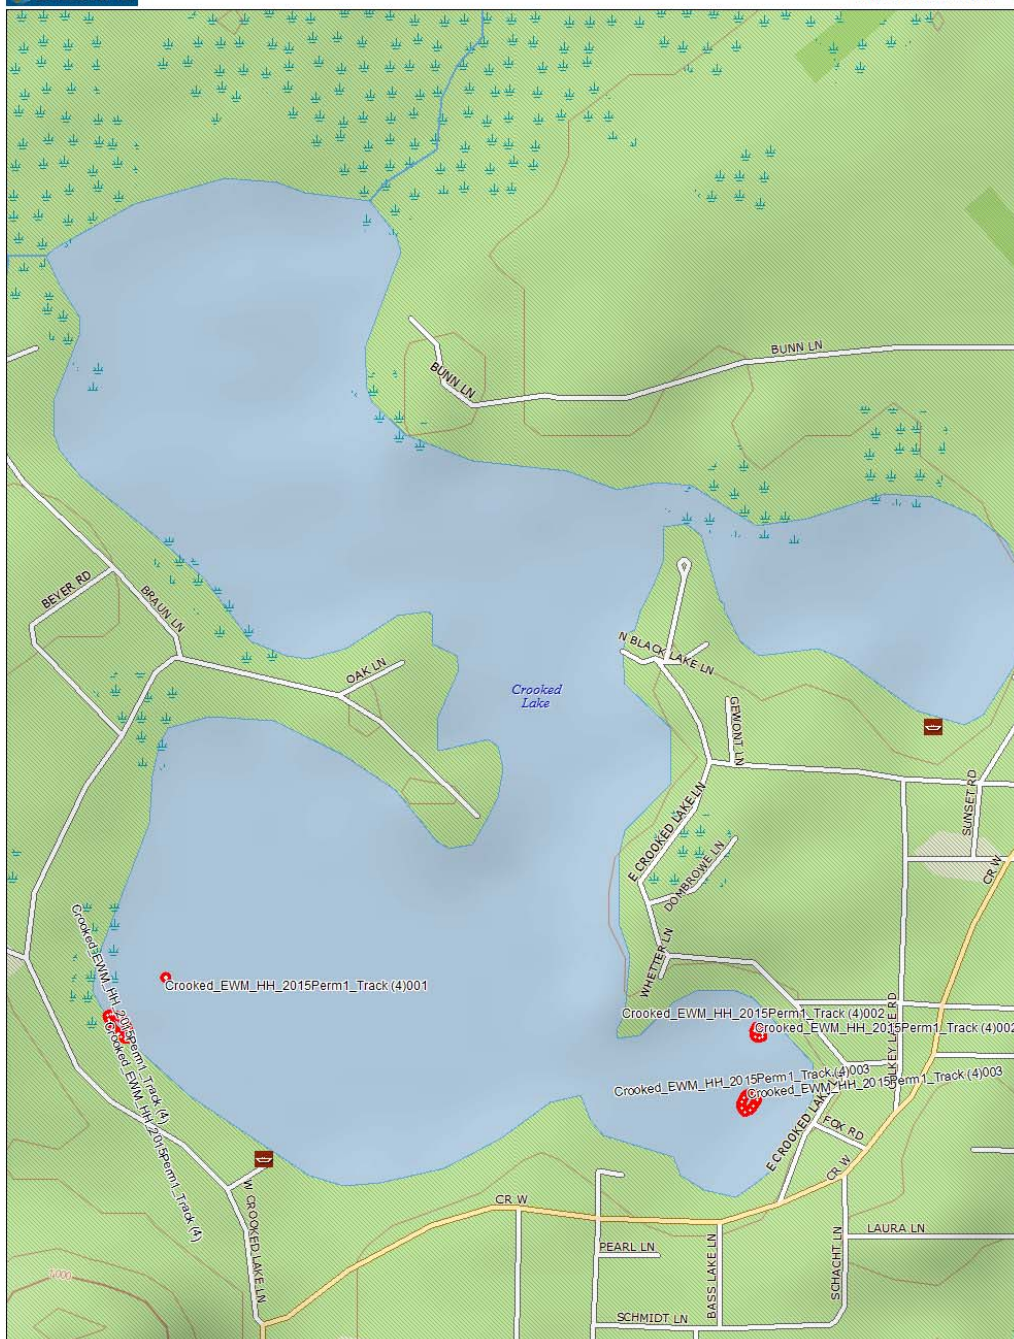
Figure 1. DASH Harvest Areas as Transferred to GPS, Crooked and Bass Lakes, Oconto County, Wisconsin, 2015.

Diver Assisted Suction Harvest (DASH) of Eurasian Water Milfoil (EWM) took place July 28, 2015 on Crooked and Bass Lakes, Oconto County, Wisconsin (Figure 1). A survey performed on June 4, 2015 reconfirmed the locations of EWM and 0.14 acres were targeted in Crooked Lake and 0.11 were targeted in Bass Lake (Figure 2). There were 5 - 10 mph winds out of the southeast with an air temperature of 75 degrees.

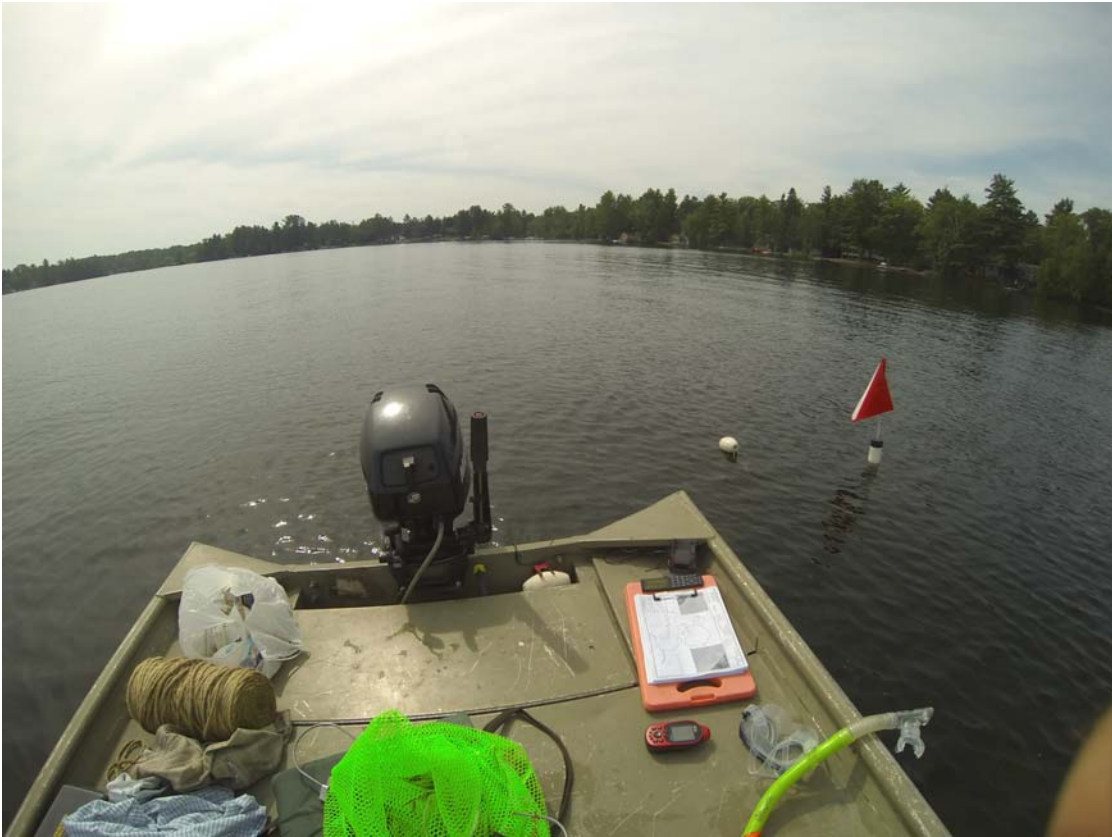
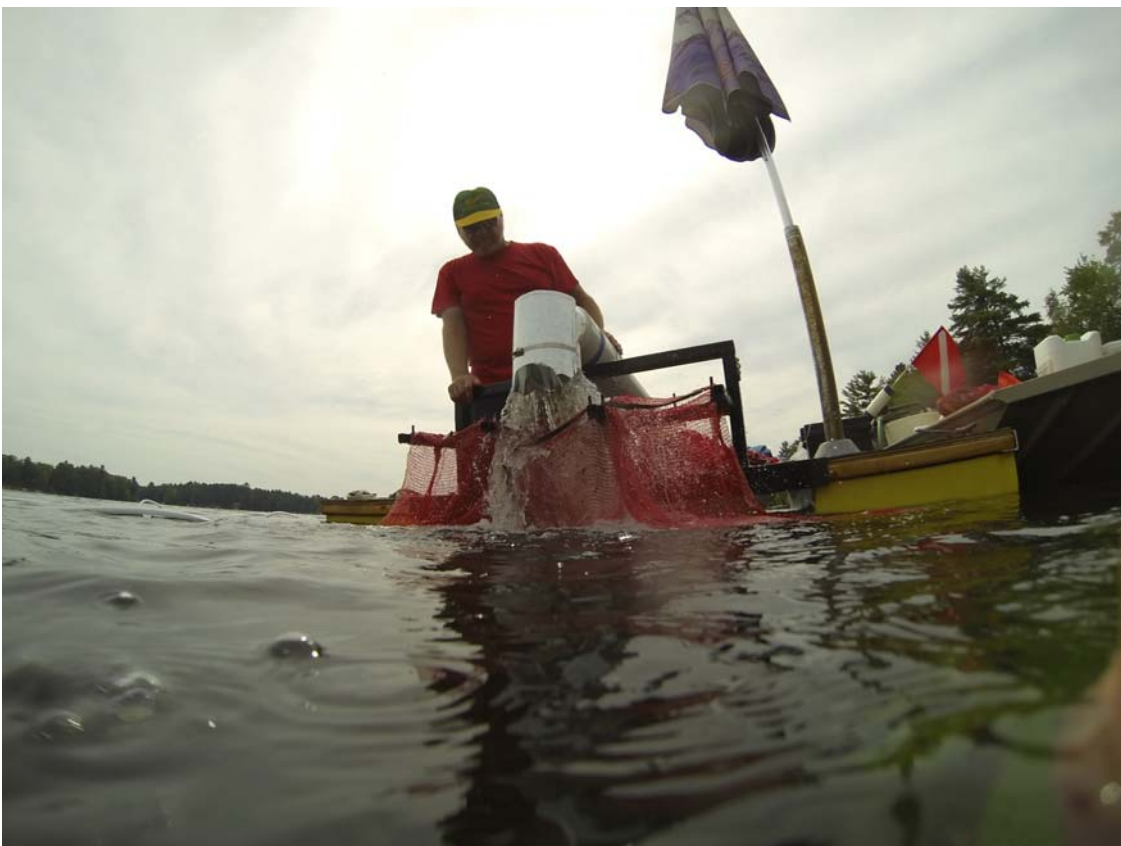
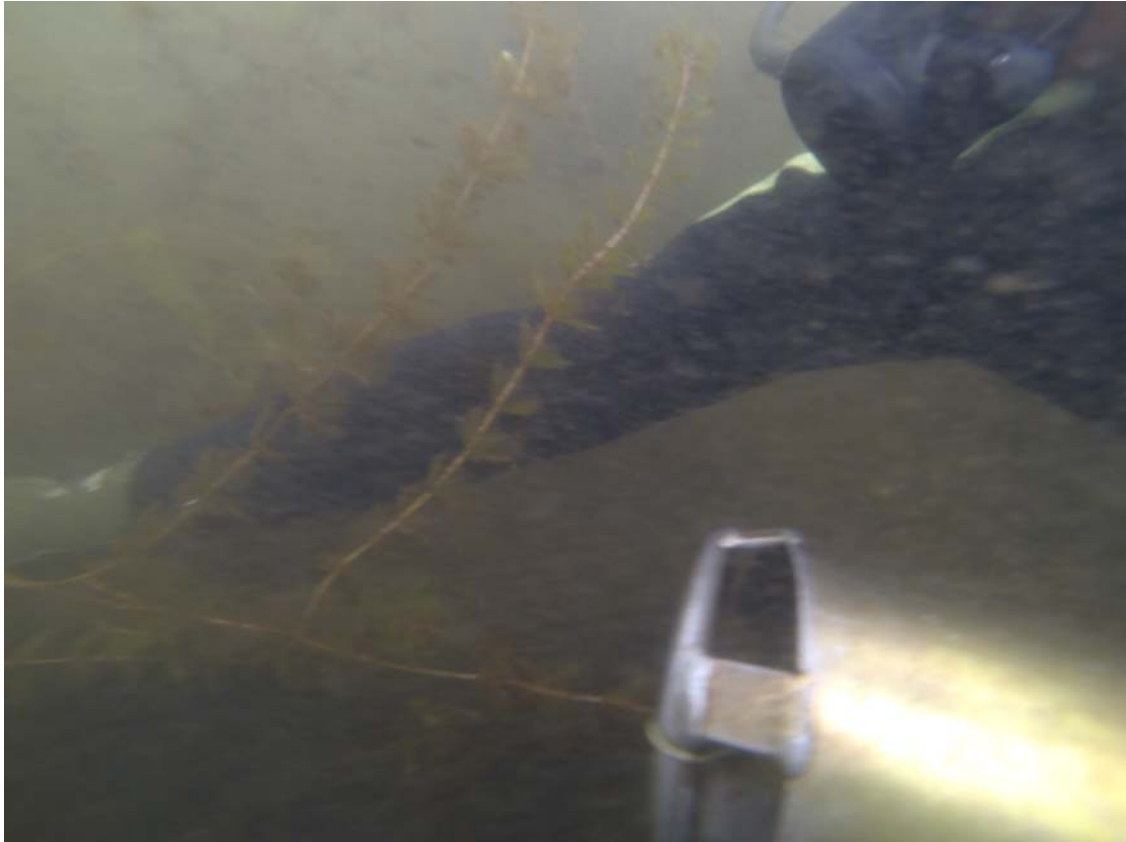
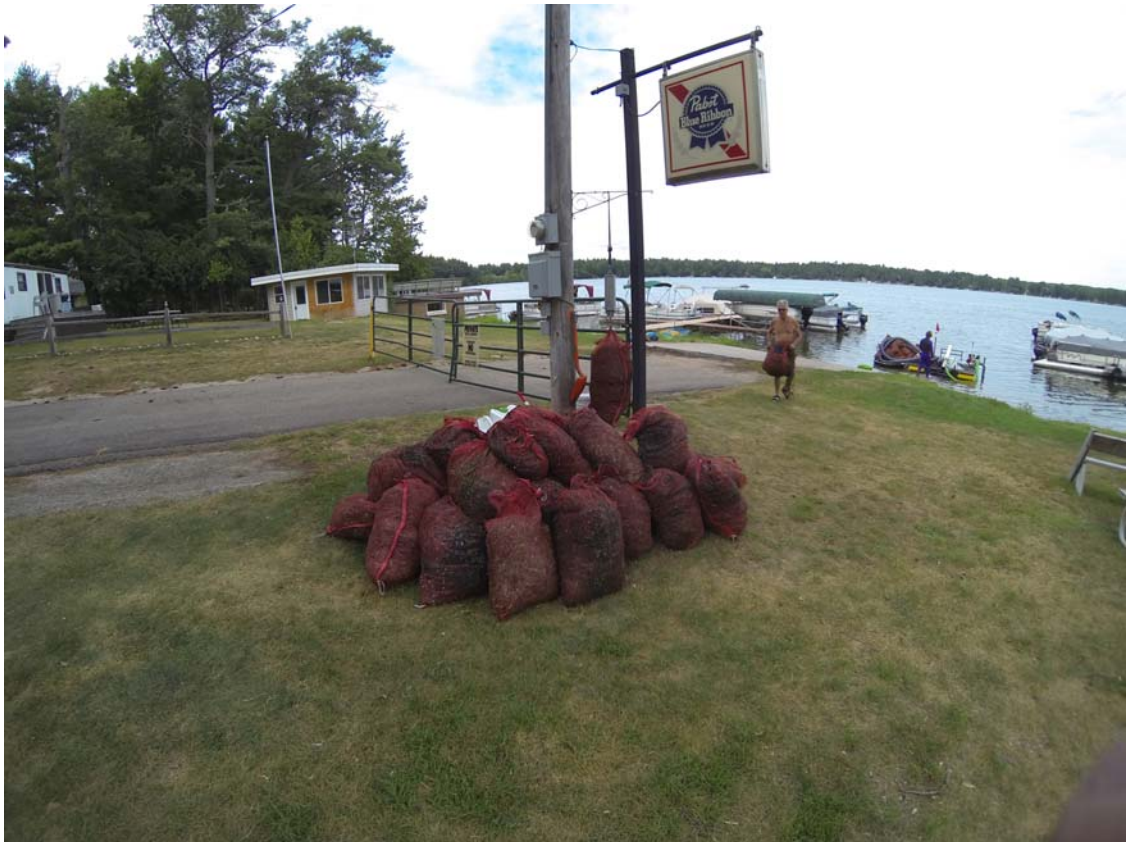
APPENDIX I  
Photos of DASH Operation

There were 3 divers utilized with 2 using the hookah air supply and suction of the barge DASH system with another diver hand harvesting using SCUBA and collecting plants in a mesh dive bags. A total of only 28 pounds of EWM was harvested during 14.0 man-hours from Crooked and Bass Lakes. The majority of the harvest came from the Crooked Lake location referred to as Z-15 (Figure 2). About 20 plants were harvested from area W-15 and Y-15 and only a single plant was located at location X-15. Local observations indicated that the EWM was more prevalent earlier in the season and seemed to be in a reduced population at the time of harvest.
