INTRODUCTION

Crooked Lake, Oconto County, is an approximate 143-acre drainage lake with a reported maximum depth of 37 feet. Gilkey and Bass Lakes, 20 and 12 acres, respectively, are smaller seepage lakes directly connected and flowing into to Crooked Lake. Gilkey Lake has a reported maximum depth of six feet and flows into Crooked Lake's northeast side, while Bass Lake has a reported maximum depth of 11 feet and is connected to Crooked Lake via a small channel on the lake's southeast side. Eurasian water milfoil (*Myriophyllum spicatum*; EWM) was first documented from Crooked, Gilkey, and Bass Lakes in 2002. Since 2008, the Crooked Lake Protection & Rehabilitation District (CLPRD) has been actively managing the EWM population through strategically targeted herbicide applications and volunteer based hand harvesting removal efforts.

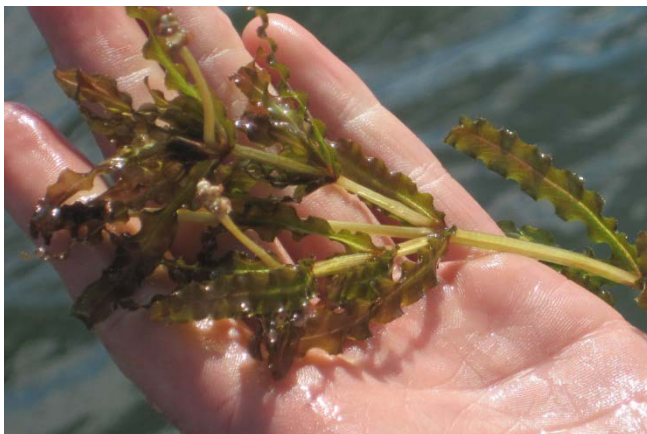
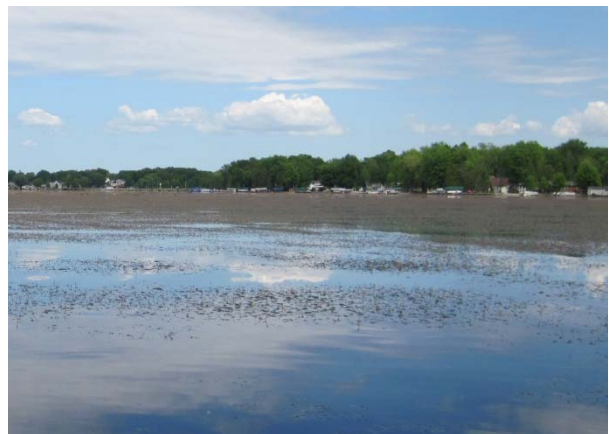
Photo 2. Close-up of CLP (left) and population (right) of surface-matted CLP on Shawano Lake, Shawano County, Wisconsin.

Curly-leaf pondweed is a European exotic first discovered in Wisconsin in the early 1900's that has an unconventional lifecycle giving it a competitive advantage over our native plants (Photo 2). The plants begin growing almost immediately after, if not immediately before, ice-out and by early-summer they reach their peak growth. As they are growing, each plant produces numerous turions (asexual reproductive structures) which break away from the plant and settle to the bottom following the plant's senescence. The deposited turions lie dormant until autumn when they sprout to produce small winter foliage, and they remain in this state until spring foliage is produced. The advanced growth in spring gives the plant a significant jump on native vegetation. In certain lakes, CLP can become so abundant that it hampers recreational activities within the lake. In instances where large CLP populations are present, its mid-summer die-back can cause significant algal blooms spurred from the release of nutrients during the plants' decomposition. However, in some lakes, mostly in northern Wisconsin, CLP appears to integrate itself within the community without becoming a nuisance. While it is not known how CLP will react in Crooked Lake, it is recommended that these single plant occurrences be targeted for hand-removal in 2015.
