Crooked Lake Area Lakes

Oconto County, Wisconsin

Comprehensive Management Plan

December 2018

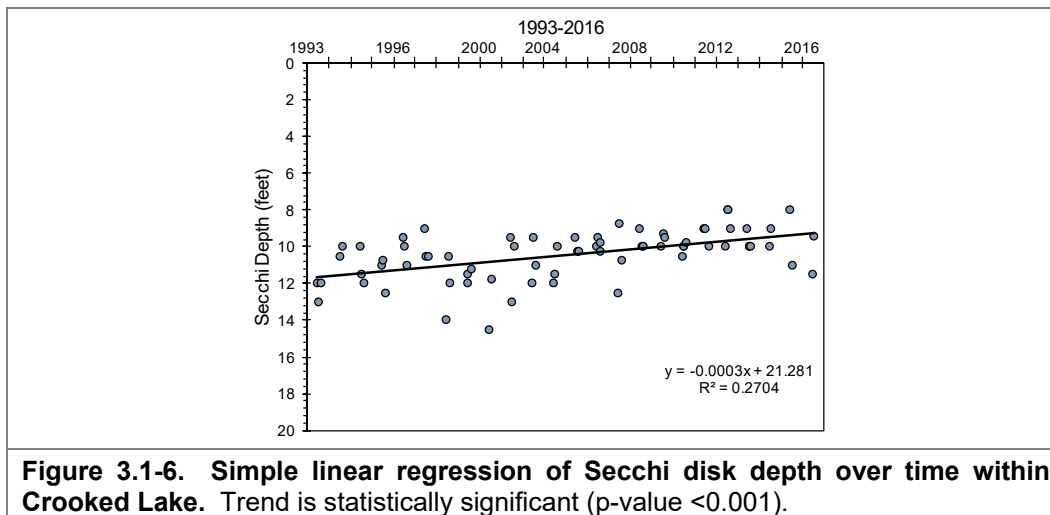
Linear regression analysis was completed on the summer Secchi disk depth data from 1993 to 2016 (Figure 3.1-6). While this linear regression yielded a low r^2 value of 0.2704, indicating high variability in the dataset, it yielded a p -value of < 0.001 indicating that Secchi disk depth has declined in Crooked Lake over the period. It is unclear why water clarity has decreased in Crooked Lake over time as total phosphorus and chlorophyll-*a* concentration have not seen statistically valid decreasing trends over essentially the same period.

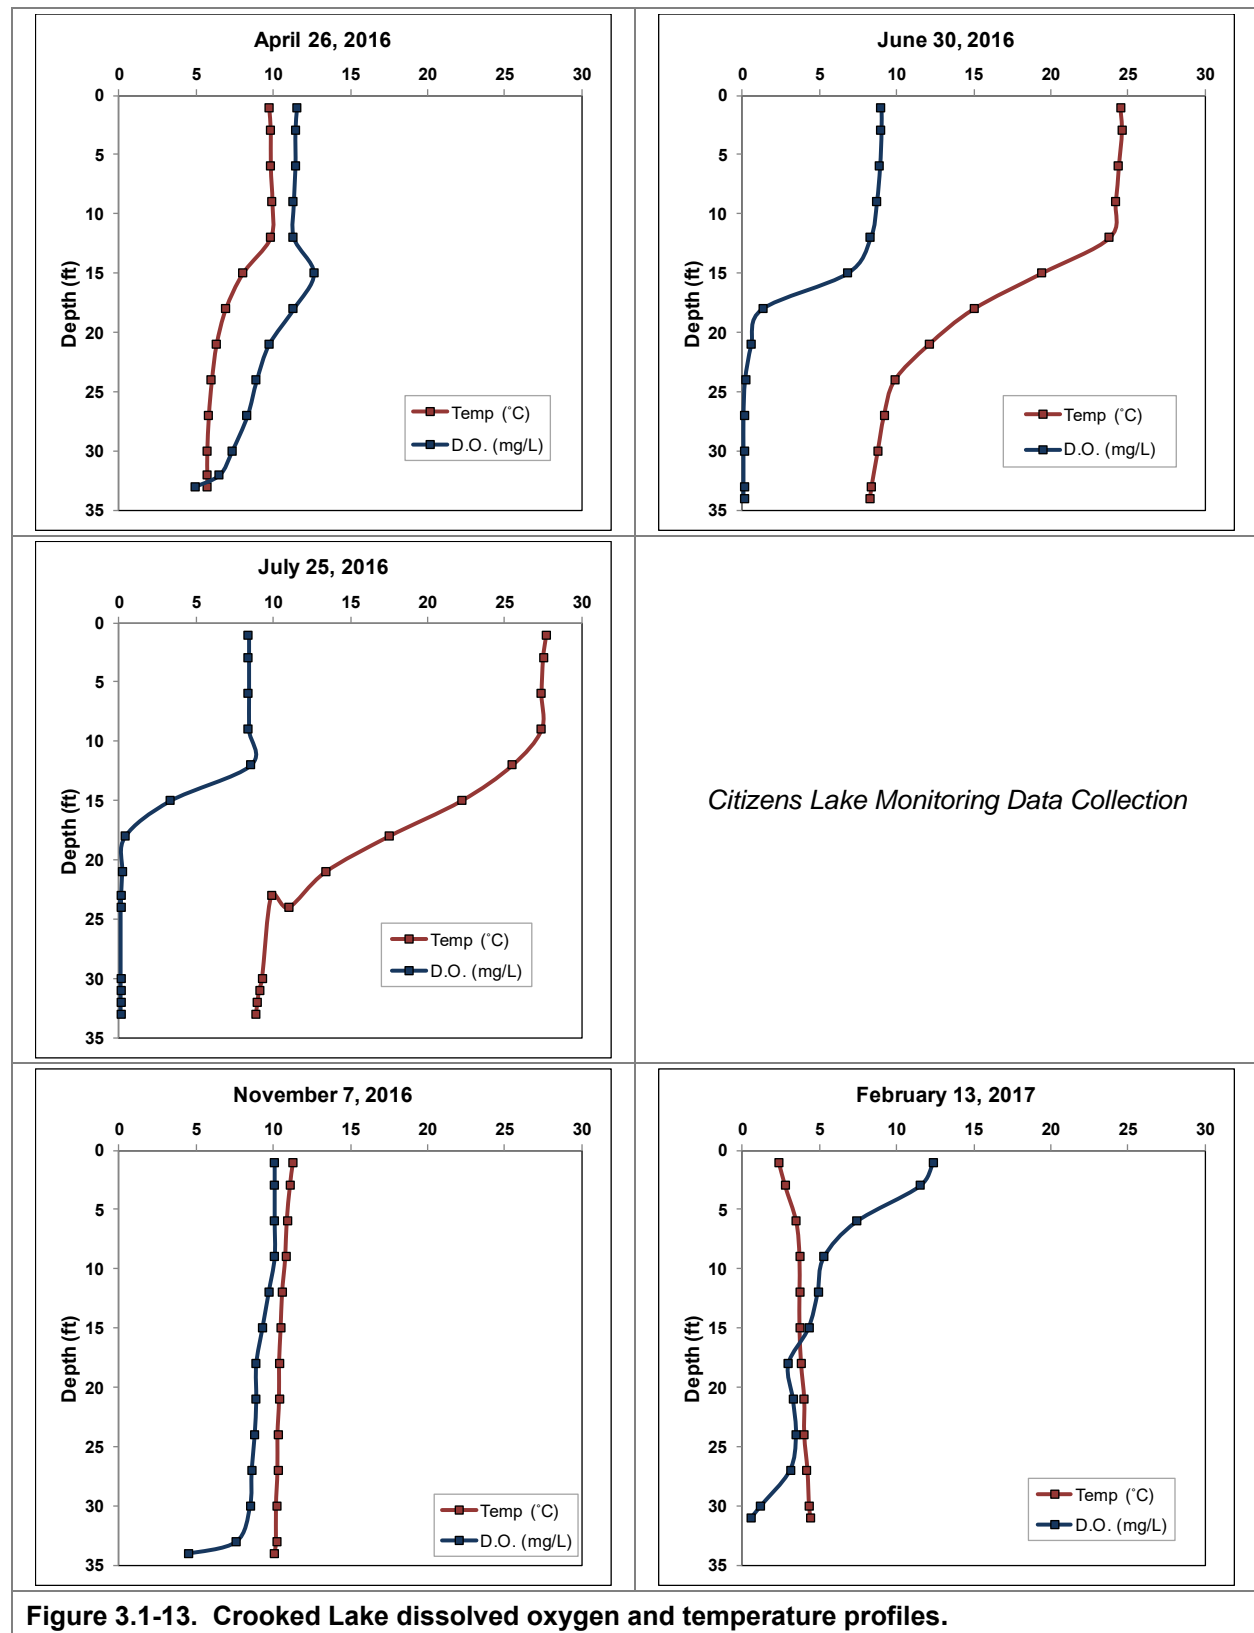
Figure 3.1-13. Crooked Lake dissolved oxygen and temperature profiles.

Dissolved oxygen and temperature were measured during water quality sampling visits to the Crooked Lake Area Lakes by Onterra staff. Profiles depicting these data are displayed in Figures 3.1-13 – 3.1-15. These data indicate that only Crooked Lake consistently stratifies during the summer and during that time, the hypolimnion becomes anoxic. This is a typical occurrence in moderately productive lakes. These data also indicate that in Crooked and Gilkey lakes there was sufficient oxygen throughout the water column under the ice to support the fishery during late-winter sampling in these lakes. However, while oxygen levels in Bass Lake did not reach zero, levels were found to be less than 3.0 mg/L below three feet. During the winter months, fish can largely withstand dissolved oxygen levels as low as 3.0 mg/L, so the bulk of Bass Lake's volume was unavailable for fish during the February 2017 sampling event. Still, there is likely only limited impact to the fisheries as fish can migrate into large oxygenated volumes in Crooked Lake.

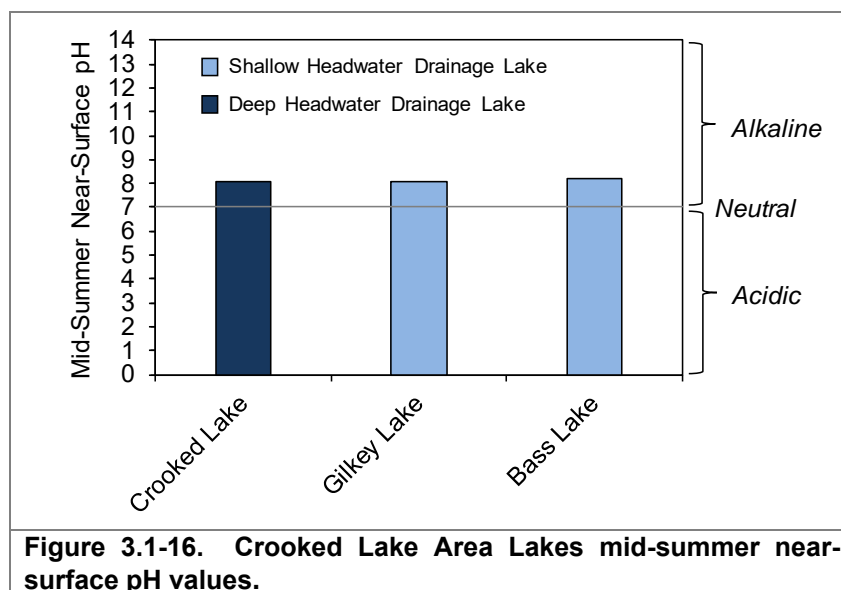
The pH scale ranges from 0 to 14 and indicates the concentration of hydrogen ions (H^+) within the lake's water and is an index of the lake's acidity. Water with a pH value of 7 has equal amounts of hydrogen ions and hydroxide ions (OH^-), and is considered to be neutral. Water with a pH of less than 7 has higher concentrations of hydrogen ions and is considered to be acidic, while values greater than 7 have lower hydrogen ion concentrations and are considered basic or alkaline. The pH scale is logarithmic; meaning that for every 1.0 pH unit the hydrogen ion concentration changes tenfold. The normal range for lake water pH in Wisconsin is about 5.2 to 8.4, though values lower than 5.2 can be observed in some acid bog lakes and higher than 8.4 in some marl lakes. In lakes with a pH of 6.5 and lower, the spawning of certain fish species such as walleye becomes inhibited (Shaw and Nimphius 1985). The pH of the water in both Crooked and Gilkey lakes were found to be a value of 8.06 which fall within the normal range for Wisconsin lakes (Figure 3.1-16). The pH of the water in Bass Lake was found to be a value of 8.21, and falls within the normal range for Wisconsin lakes. All three lakes have a slightly alkaline pH value.

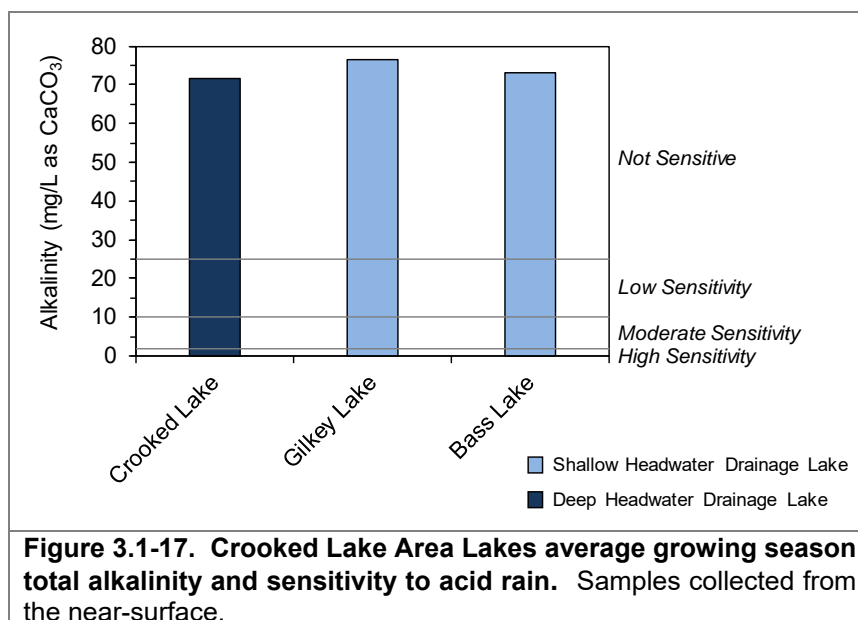
acid inputs. The alkalinity in Crooked Lake was measured at 71.7 (mg/L as CaCO₃), the alkalinity in Gilkey Lake was measured at 76.4, and the alkalinity in Bass Lake was measured at 73.0, indicating that the lakes have a substantial capacity to resist fluctuations in pH and have no sensitivity to acid rain (Figure 3.1-17).

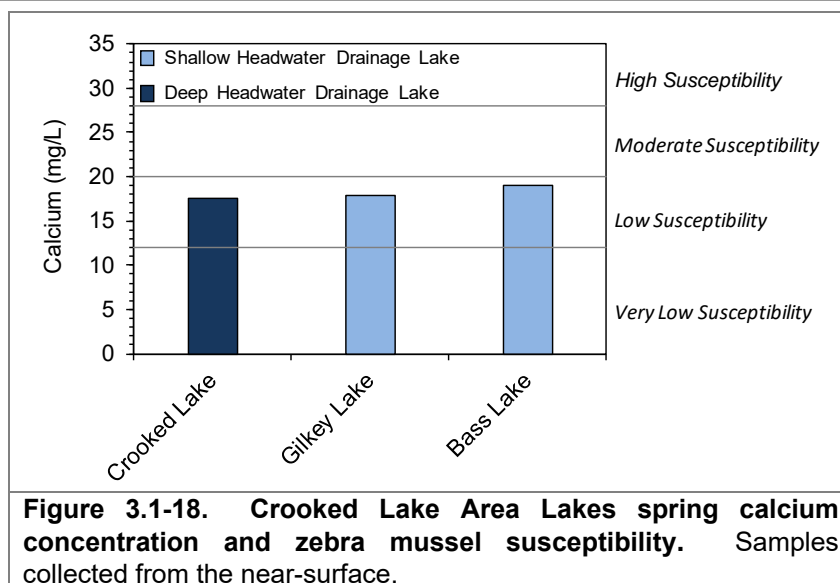
Like associated pH and alkalinity, the concentration of calcium within a lake’s water depends on the geology of the lake’s watershed. Recently, the combination of calcium concentration and pH has been used to determine what lakes can support zebra mussel populations if they are introduced. The commonly accepted pH range for zebra mussels is 7.0 to 9.0, so the Crooked Lake Area Lakes’ pH falls inside this range. Lakes with calcium concentrations of less than 12 mg/L are considered to have very low susceptibility to zebra mussel establishment. The calcium concentration of Crooked Lake was found to be 17.5 mg/L, Gilkey Lake was found to be 17.9, and Bass Lake was found to be 19.10, all three falling into the low susceptibility range for zebra mussel establishment (Figure 3.1-18).

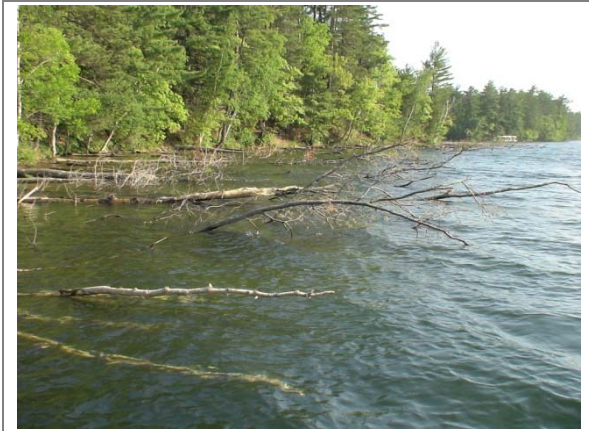
Photograph 3.3-1. Example of coarse woody habitat in a lake.

Coarse woody habitat has shown to be advantageous for fisheries in terms of providing refuge, foraging area, as well as spawning habitat (Hanchin et al 2003). In one study, researchers observed 16 different species occupying coarse woody habitat areas in a Wisconsin lake (Newbrey et al. 2005). Bluegill and bass species in particular are attracted to this habitat type; largemouth bass stalk bluegill in these areas while the bluegill hide amongst the debris and often feed upon many macroinvertebrates found in these areas, who themselves are feeding upon algae and periphyton growing on the wood surface. Newbrey et al. (2005) found that some fish species prefer different complexity of branching on coarse woody habitat, though in general some degree of branching is preferred over coarse woody habitat that has no branching.

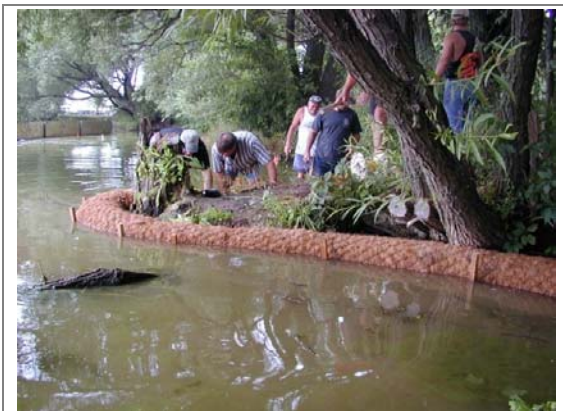
Photograph 3.3-2. Example of a biological restoration site.

In recent years, many lakefront property owners have realized increased aesthetics, fisheries, property values, and water quality by restoring portions of their shoreland to mimic its unaltered state. An area of shore restored to its natural condition, both in the water and on shore, is commonly called a shoreland buffer zone. The shoreland buffer zone creates or restores the ecological habitat and benefits lost by traditional suburban landscaping. Simply not mowing within the buffer zone does wonders to restore some of the shoreland’s natural function.

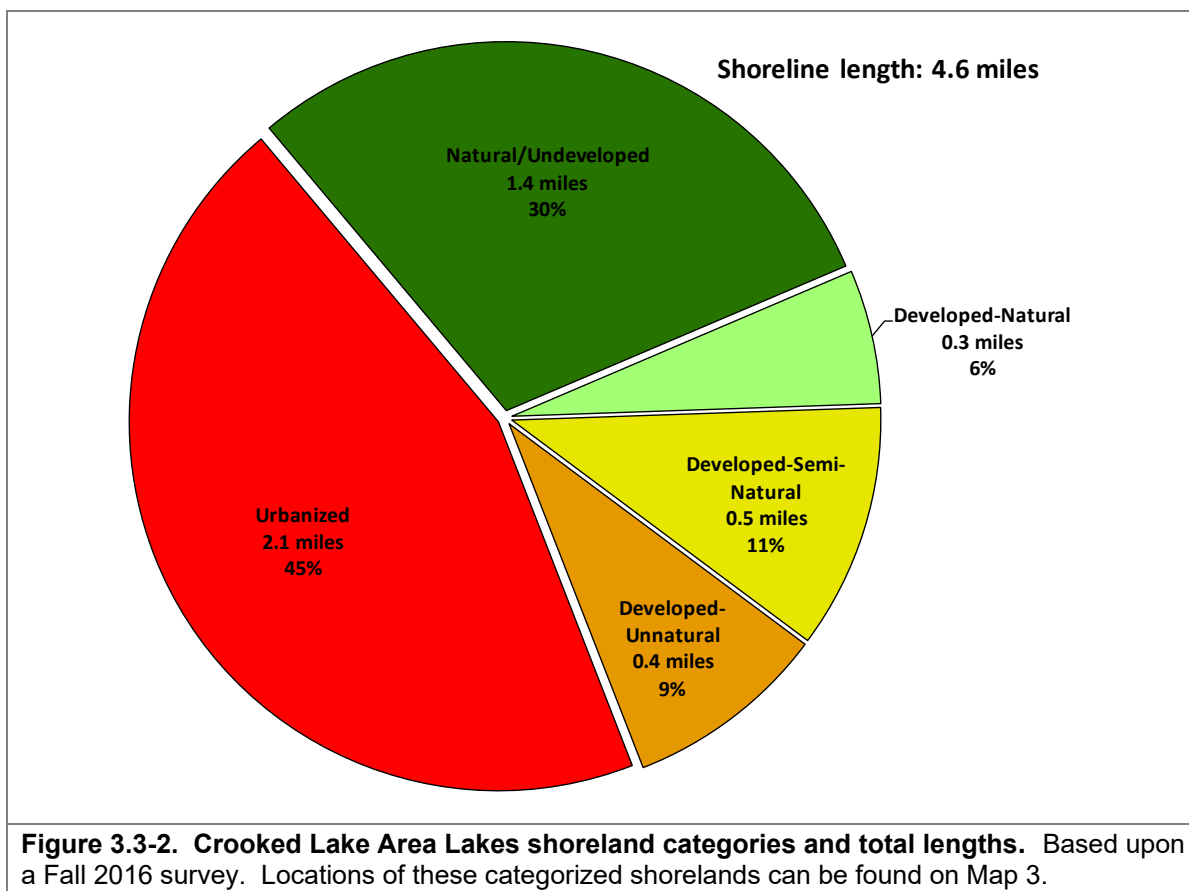
The Crooked Lake Area Lakes have stretches of shoreland that fit all of the five shoreland assessment categories. In all, 1.7 miles of *natural/undeveloped* and *developed-natural* shoreland were observed during the survey (Figure 3.3-2). These shoreland types provide the most benefit to the lake and should be left in their natural state if at all possible. During the survey, 2.5 miles of urbanized and developed-unnatural shoreland were observed. If restoration of the Crooked Lake Area Lakes' shoreland is to occur, primary focus should be placed on these shoreland areas as they currently provide little benefit to, and actually may harm, the lakes ecosystem.

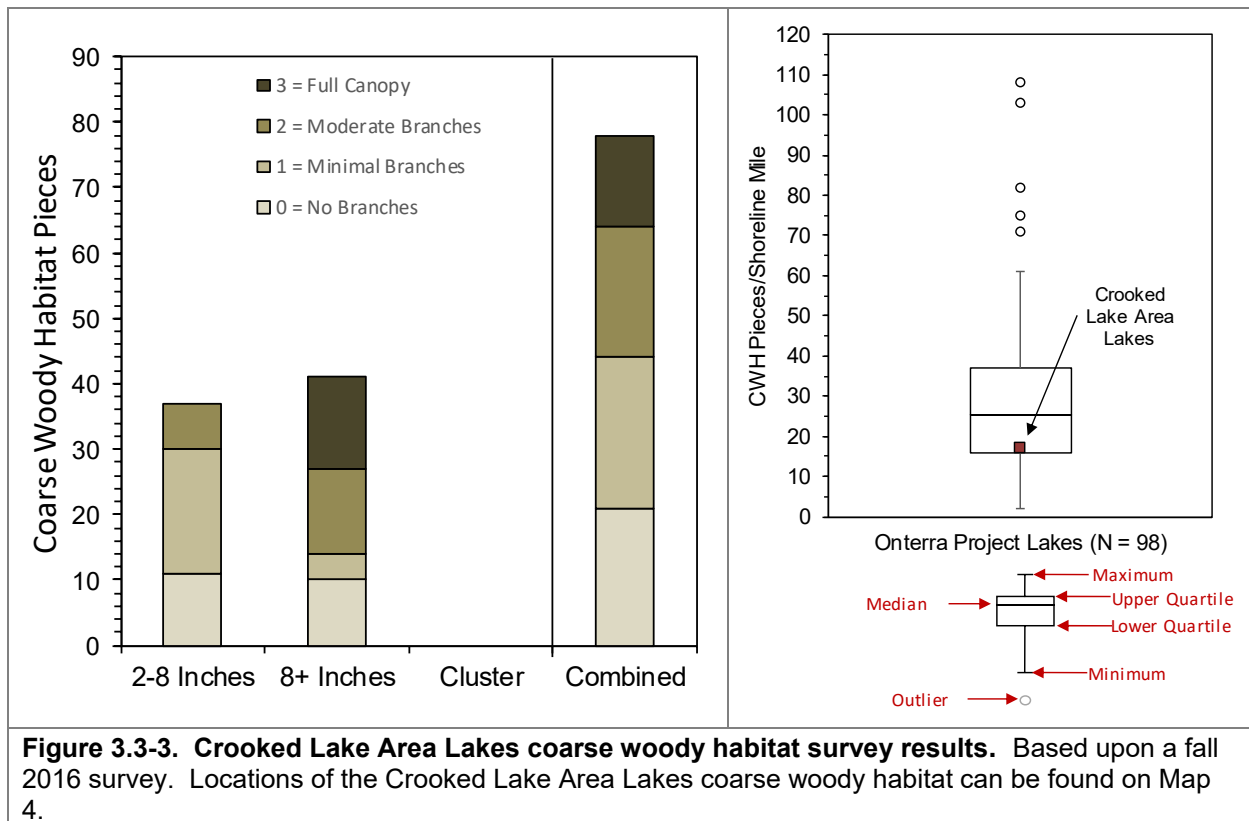
During this survey, 78 total pieces of coarse woody habitat were observed along 4.6 miles of shoreline (Map 4), which gives the Crooked Lake Area Lakes a coarse woody habitat to shoreline mile ratio of 17:1 (Figure 3.3-3). Only instances where emergent coarse woody habitat extended from shore into the water were recorded during the survey. Thirty-seven pieces of 2-8 inches in diameter pieces of coarse woody habitat were found, 41 pieces of 8+ inches in diameter pieces of coarse woody habitat were found, and no instances of clusters of pieces of coarse woody habitat were found.

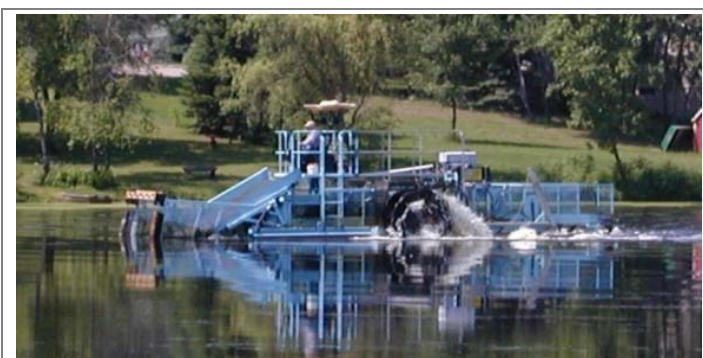
Photograph 3.4-3. Mechanical harvester.

Aquatic plant harvesting is frequently used in Wisconsin and involves the cutting and removal of plants much like mowing and bagging a lawn. Harvesters are produced in many sizes that can cut to depths ranging from 3 to 6 feet with cutting widths of 4 to 10 feet. Plant harvesting speeds vary with the size of the harvester, density and types of plants, and the distance to the off-loading area. Equipment requirements

do not end with the harvester. In addition to the harvester, a shore-conveyor would be required to transfer plant material from the harvester to a dump truck for transport to a landfill or compost site. Furthermore, if off-loading sites are limited and/or the lake is large, a transport barge may be needed to move the harvested plants from the harvester to the shore in order to cut back on the time that the harvester spends traveling to the shore conveyor. Some lake organizations contract to have nuisance plants harvested, while others choose to purchase their own equipment. If the latter route is chosen, it is especially important for the lake group to be very organized and realize that there is a great deal of work and expense involved with the purchase, operation, maintenance, and storage of an aquatic plant harvester. In either case, planning is very important to minimize environmental effects and maximize benefits.

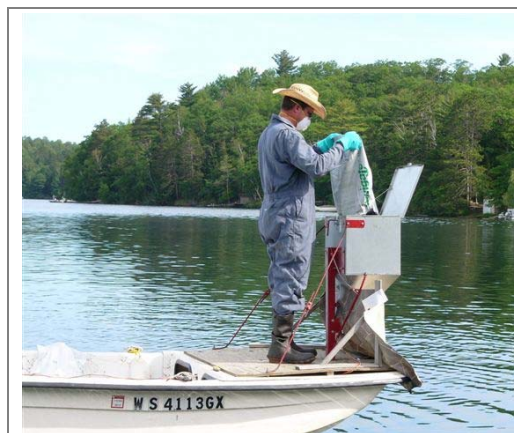
Photograph 3.4-4. Granular herbicide application.

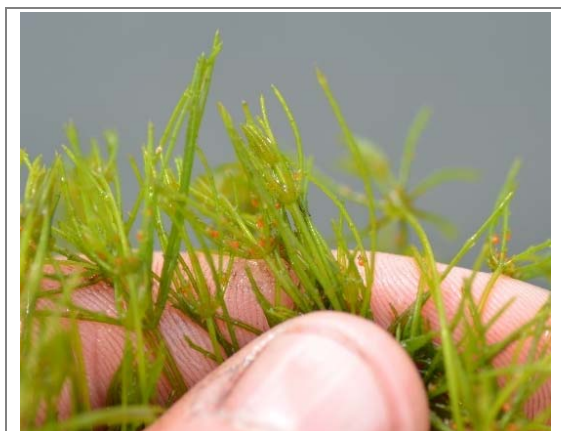
Photograph 3.4-5. The aquatic macroalgae muskgrasses (Chara spp.).
Photo credit Onterra.

Muskgrasses are a genus of macroalgae of which there are seven species in Wisconsin (Photograph 3.4-5). In 2016, muskgrasses, the third-most encountered aquatic plant, had a littoral frequency of occurrence of approximately 20% (Figure 3.4-5). Dominance of the aquatic plant community by muskgrasses is common in alkaline lakes like Crooked Lake, and these macroalgae have been found to be more competitive against vascular plants (e.g. pondweeds, milfoils, etc.) in lakes with higher concentrations of calcium carbonate in the sediment (Kufel and Kufel 2002; Wetzel 2001). Muskgrasses require lakes with good water clarity, and their large beds stabilize bottom sediments. Studies have also shown that muskgrasses sequester phosphorus in the calcium carbonate incrustations which form on these plants, aiding in improving water quality by making the phosphorus unavailable to phytoplankton (Coops 2002). In Crooked Lake, muskgrasses were most abundant between three and thirteen feet in 2016.

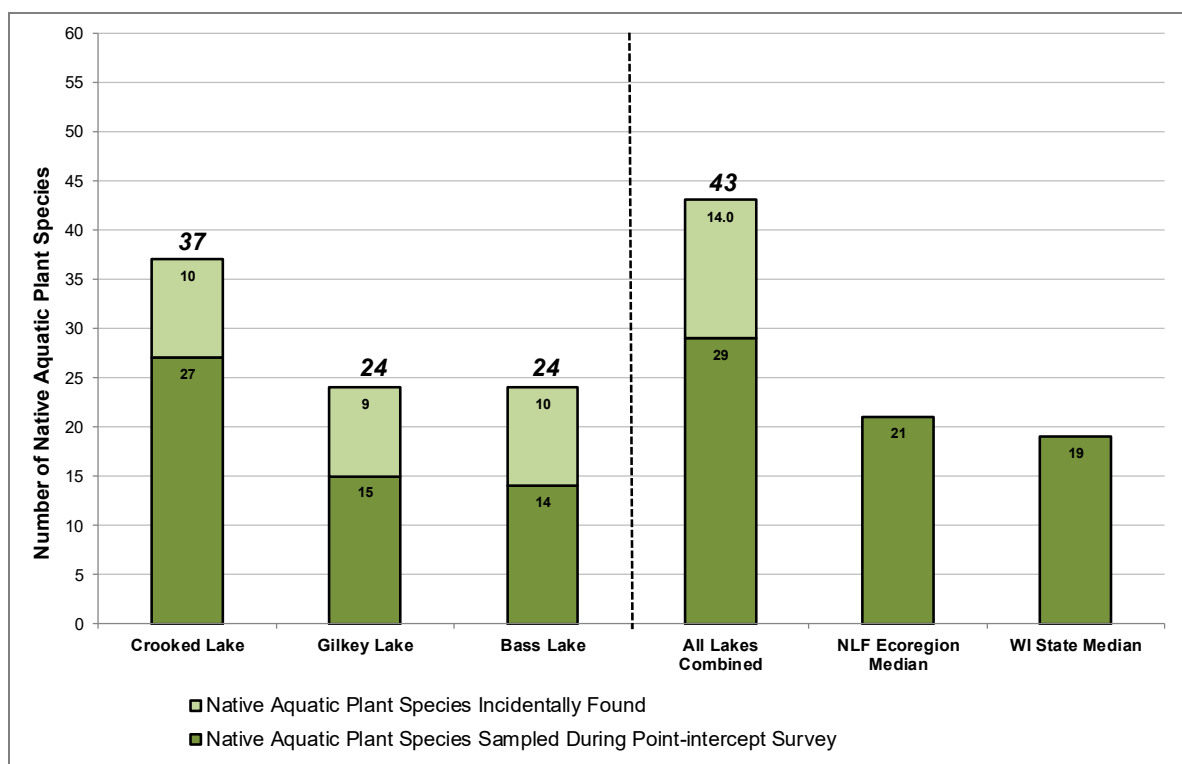
Figure 3.4-11. Crooked Lake Area Lakes species richness. Created using data from the August 2016 surveys. Analysis follows Nichols (1999).

decreased from 20 species found during the 2011 point-intercept surveys to 16 and 14 species, respectively.

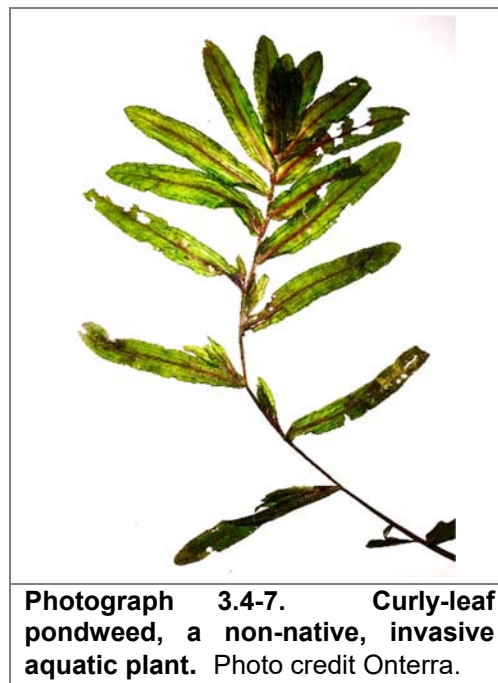
Photograph 3.4-7. Curly-leaf pondweed, a non-native, invasive aquatic plant. Photo credit Onterra.

Curly-leaf pondweed (*Potamogeton crispus*), another non-native exotic plant species commonly found in Wisconsin, was discovered within Crooked Lake in 2014. Limited hand-harvesting efforts were directed at the known CLP occurrences in 2014 and 2015 in an effort to maintain the low-density population in the lake. CLP is at or near its peak growth in early summer before naturally senescing (dying back) in mid-summer, making early summer the most probable time to locate this species. Onterra ecologists located several CLP occurrences in the approximate area in which it was documented in 2014-2016 in the eastern portion of Crooked Lake during the June 2017 ESAIS survey as well as a small colony of *scattered* CLP in the northern portion of Crooked Lake (Figure 3.4-19). A *clump of plants* as well as two *single or few* CLP plants were found within Bass Lake.

The CLP population in Crooked Lake was found to have expanded somewhat since previous surveys, although is still considered relatively modest (Figure 3.4-19). In certain lakes, CLP can become so abundant that it hampers recreational activities within the lake. In instances where large CLP populations are present, its mid-summer die-back can cause significant algal blooms spurred from the release of nutrients during the plants' decomposition. However, in some lakes, mostly in northern Wisconsin, CLP appears to integrate itself within the community without becoming a nuisance.

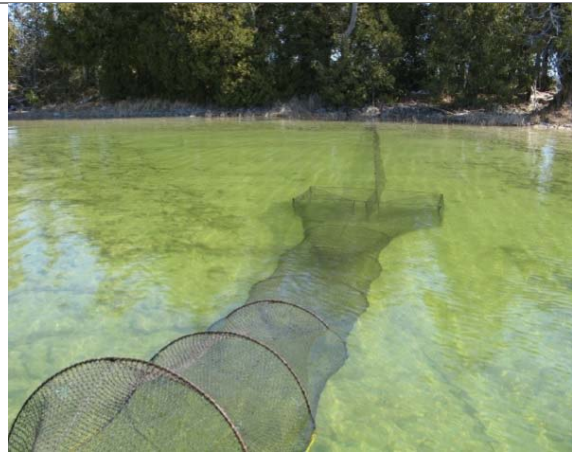
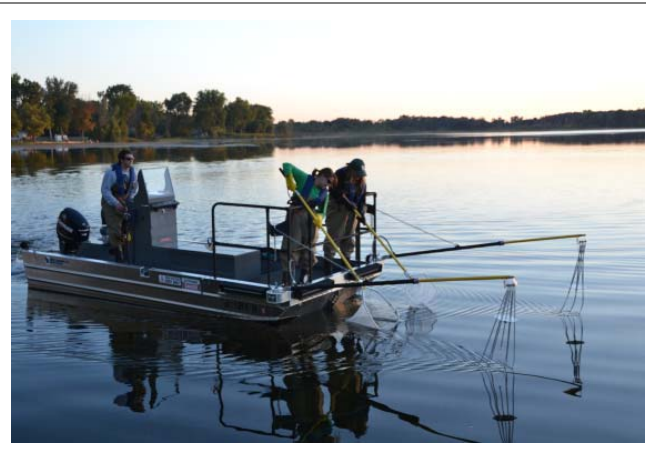
Photograph 3.6-1. Fyke net positioned in the littoral zone of a Wisconsin Lake (left) and an electroshocking boat (right).

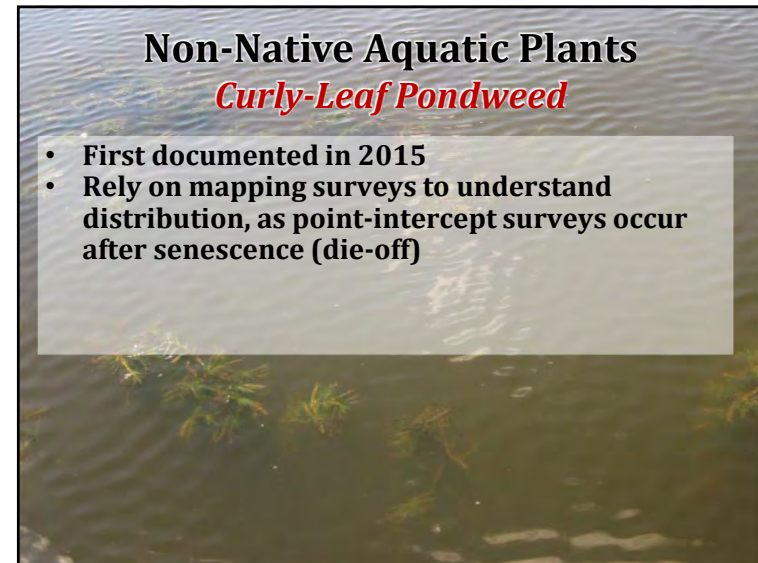
CLP Life-Cycle & Control Strategy Philosophy

- CLP respond well to herbicides (*easy to kill*)
- Herbicide strategy requires repetition (*5-7+ years in a row*)
- Hand-harvesting is analogous to single treatment (*ineffective for established populations*)
- Winter drawdown may result in multiple years of control
